Environmental Monitoring Report  
July – December 2020

## Cambodia: Provincial Water Supply and Sanitation Project

CAM: Provincial Water Supply and Sanitation Project –  
Sanitation Component

**SMR-E Report Number: 3**

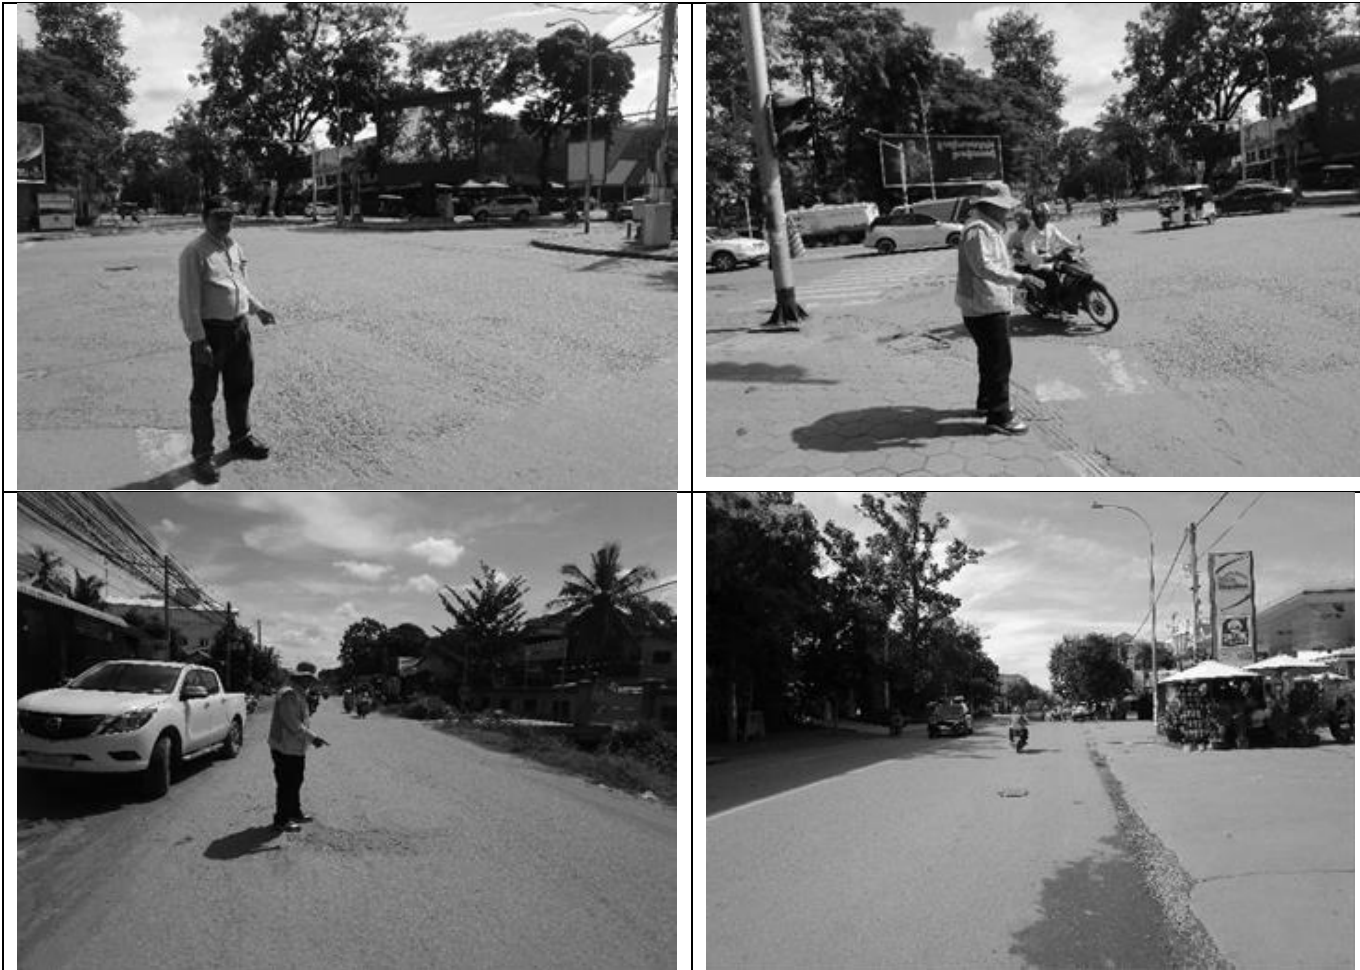
*Siem Reap: The manhole sites in the roadway are well filled and maintained (September 2020)*

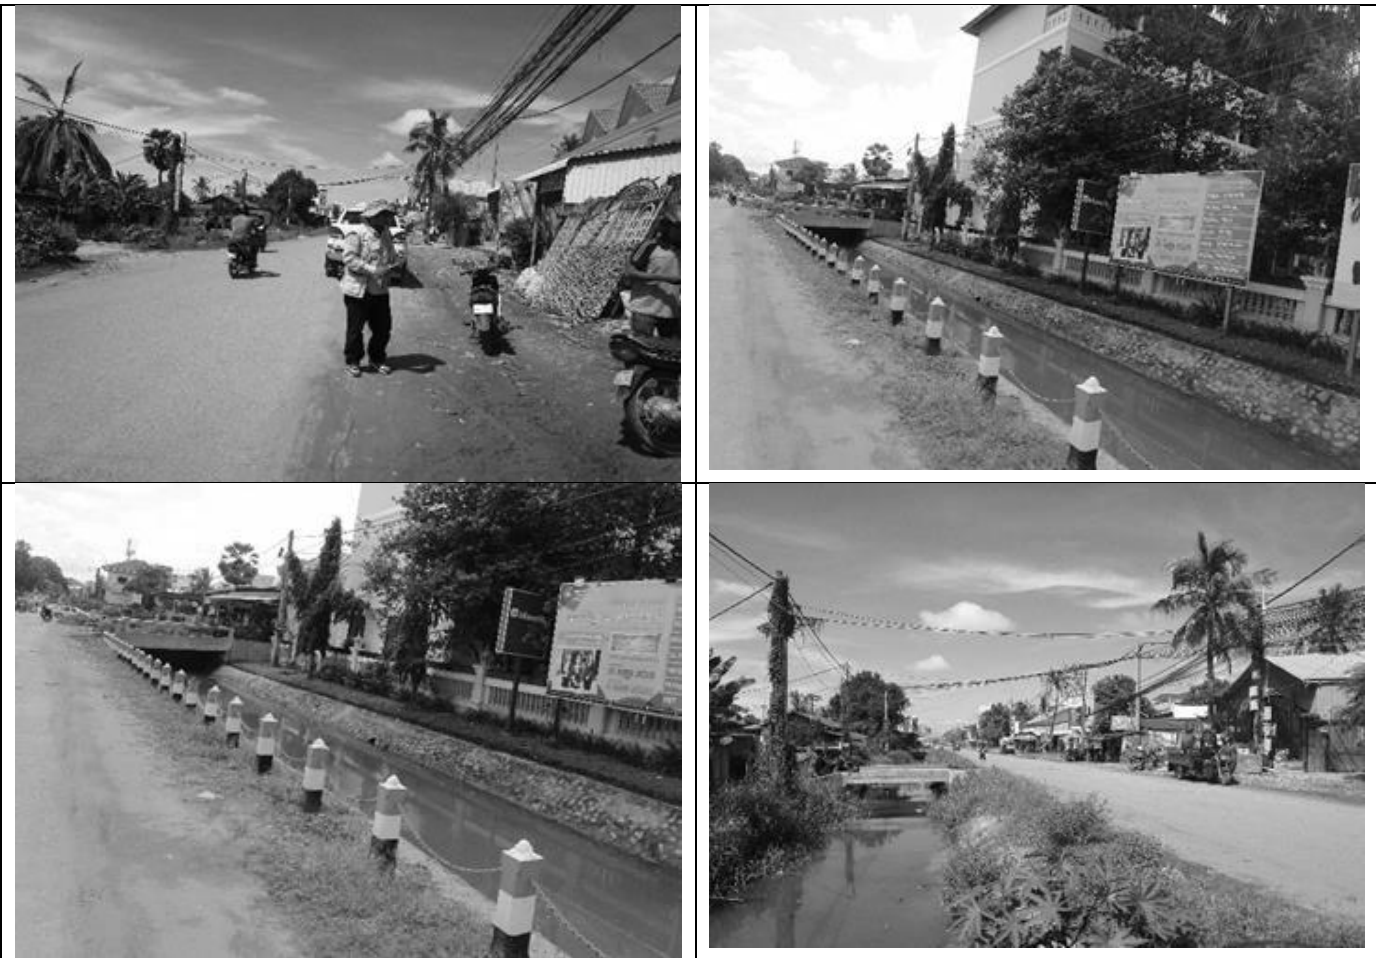
*Siem Reap: Road conditions in Thmei and Phear Chay village with access over open canal (September 2020)*

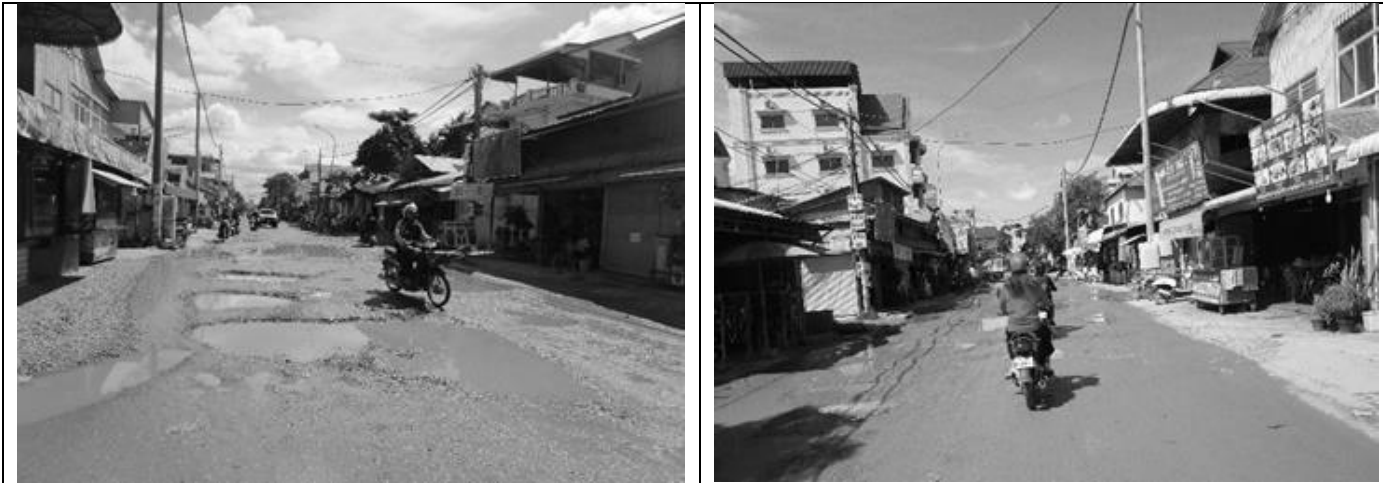
- *Issues Raised:* People in Vihear Chean village, Svay Dankum commune complained in September 2020 that during rainy season the existing road in this section was flooded by rain water and that runoff is taking longer time than before construction, which they expect is caused by silted up drains and culverts. They proposed that as part of road improvement, the project should improve/rehabilitate the side drains and culverts. The fact of the matter is that the storms in September were one of the heaviest events in the past 25 years and therefore inundation due to pooling of surface runoff lasted longer than in recent memory.

*Siem Reap: The poor road section in Vihear Chean village with inadequate side drainage (September 2020)*

40. With respect to Siem Reap subproject, trench stabilization is required and condition of existing road in a condition where rehabilitation is recommended along the full length of the project roads. The final concept for trench stabilisation and road rehabilitation, will include permanent seal of the road and the reinstatements outstanding will be completed along with road reseal.
41. With respect to Battambang subproject, the main recommendations relate to the preparation for environmental management by the contractor, including a CEMP with associated sub-plans as detailed in the EMP. The contractor is to nominate environment, health and safety officer(s) and community liaison / GRM focal point. Training needs and activities will be assessed and conducted following the nominations/appointments.

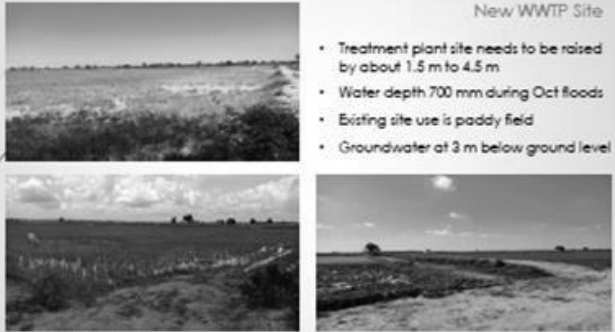
New WWTP Site

- Treatment plant site needs to be raised by about 1.5 m to 4.5 m
- Water depth 700 mm during Oct floods
- Existing site use is paddy field
- Groundwater at 3 m below ground level

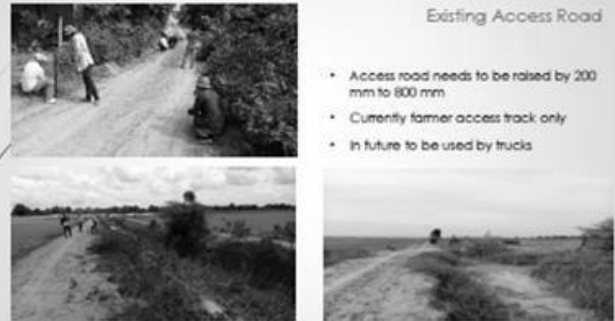
Existing Access Road

- Access road needs to be raised by 200 mm to 800 mm
- Currently farmer access track only
- In future to be used by trucks
